## Lab Information Circular

Volume 64,  
March 2012

### Fracture Filling - Revisited

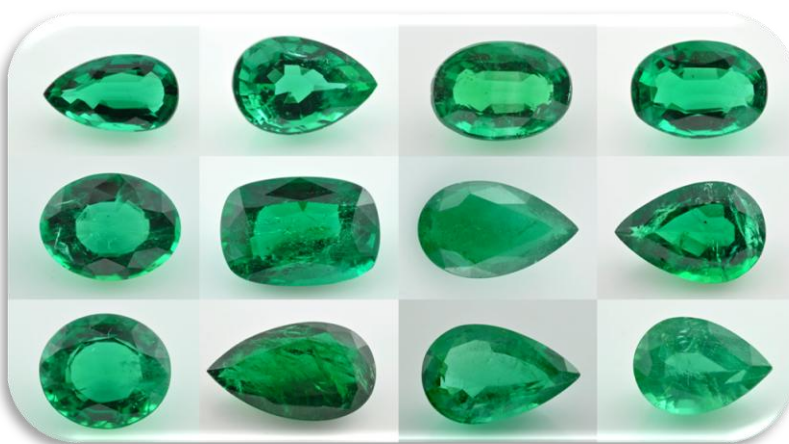
*Figure 1: Range of emeralds in various transparencies with no filler substance (top row), with oil (middle row) and with resin (bottom row)*

difference in the refractive index of the air and the stone, light gets scattered or reflected and the fissures are easily visible. By filling the substances that almost match the refractive indices of emerald make the fissures less visible, especially to the unaided eyes. Since, light transmits properly through the stone, the colour also enhances. Although, coloured oils and resins are also used to fill emeralds, we are not focusing these here.
